SCREENING SITE INSPECTION REPORT
FOR
BELVIDERE MUNICIPAL LANDFILL #2
BELVIDERE, ILLINOIS
U.S. EPA ID: ILD000605113
SS ID: NONE
TDD: F05-8902-021
PAN: FIL0584SA

MARCH 22, 1990

ecology and environment, inc.

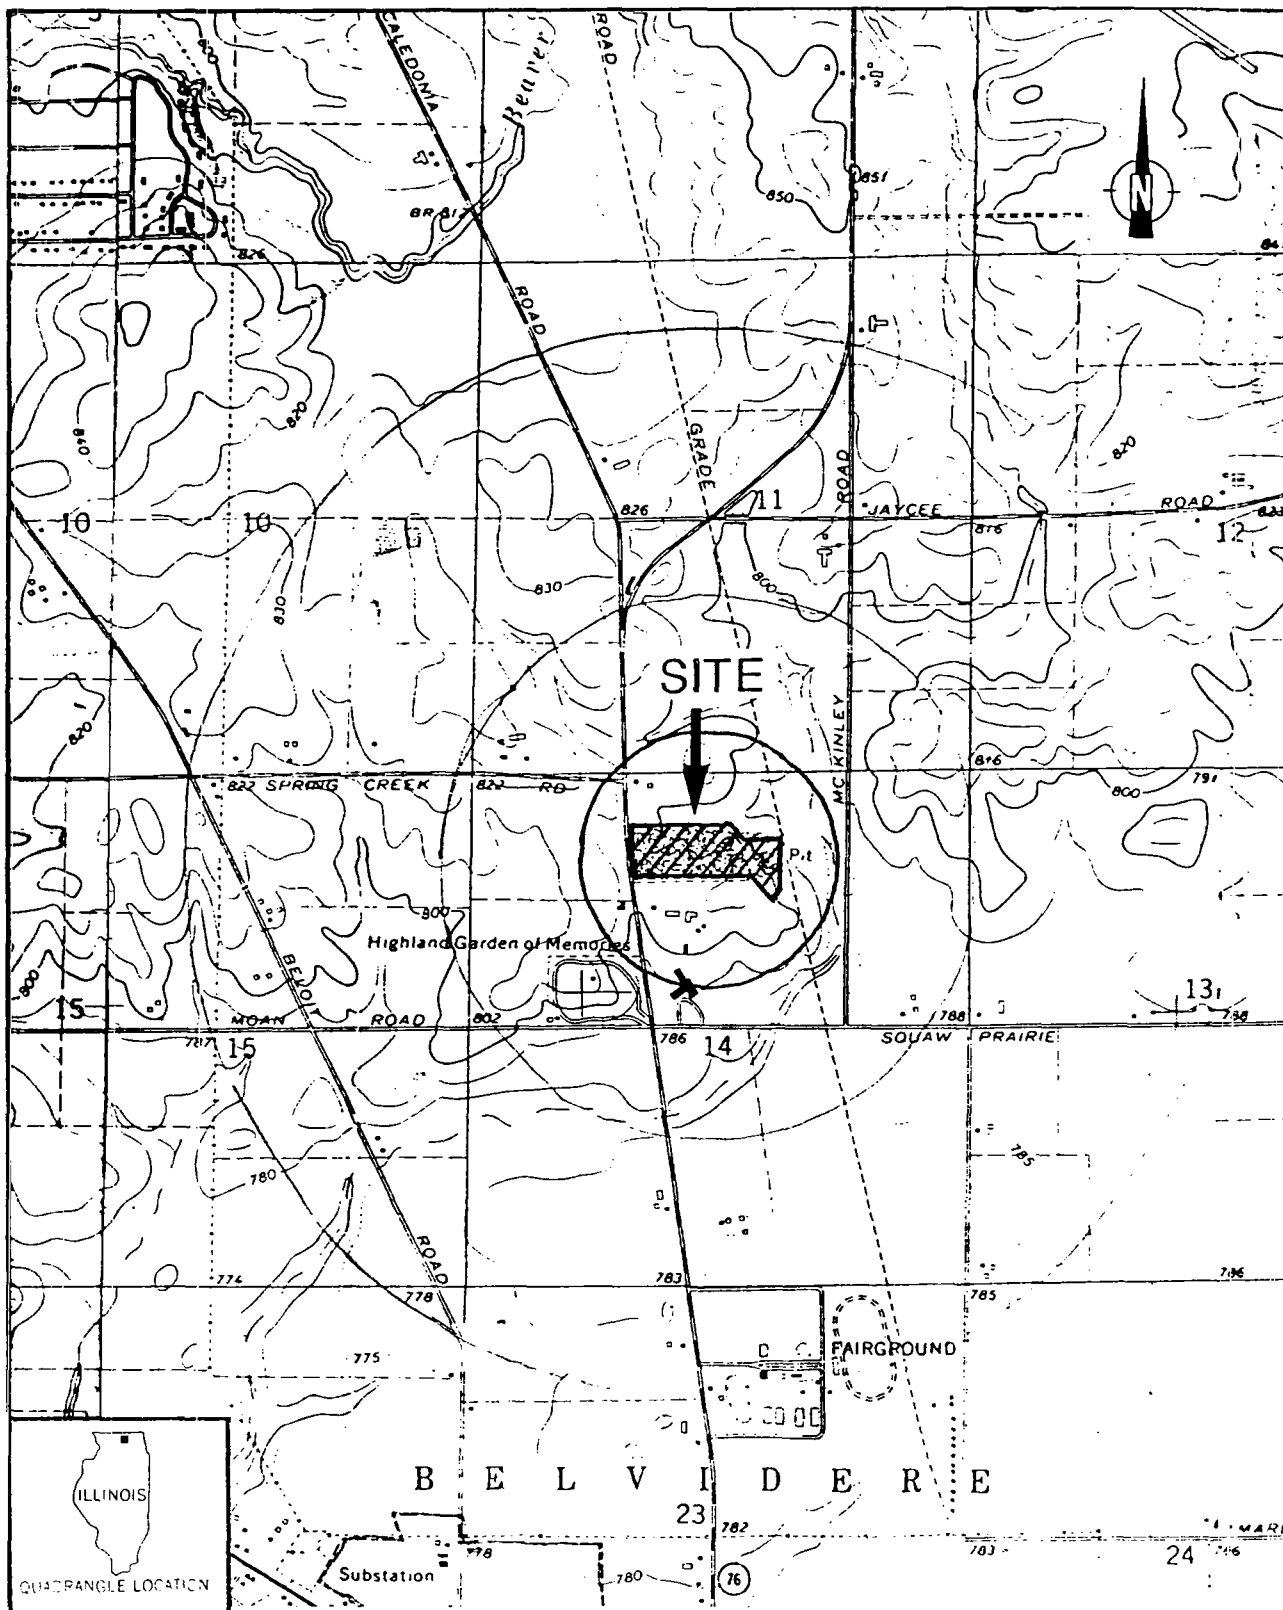
FIGURE 2-1 SITE LOCATION

The BML site is an active landfill that currently accepts municipal refuse from the residents of Boone County, Illinois, and local manufacturers from the city of Belvidere, Illinois. The site is located on approximately 34 acres of land 2 miles north of Belvidere, in Boone County (S1/2NW1/4NE1/4 and S1/2NE1/4NW1/4 sec. 14, T.44N., R.3E.), east of Illinois Route 76 (see Figure 2-1). A 4-mile radius map of the BML site is provided in Appendix A.

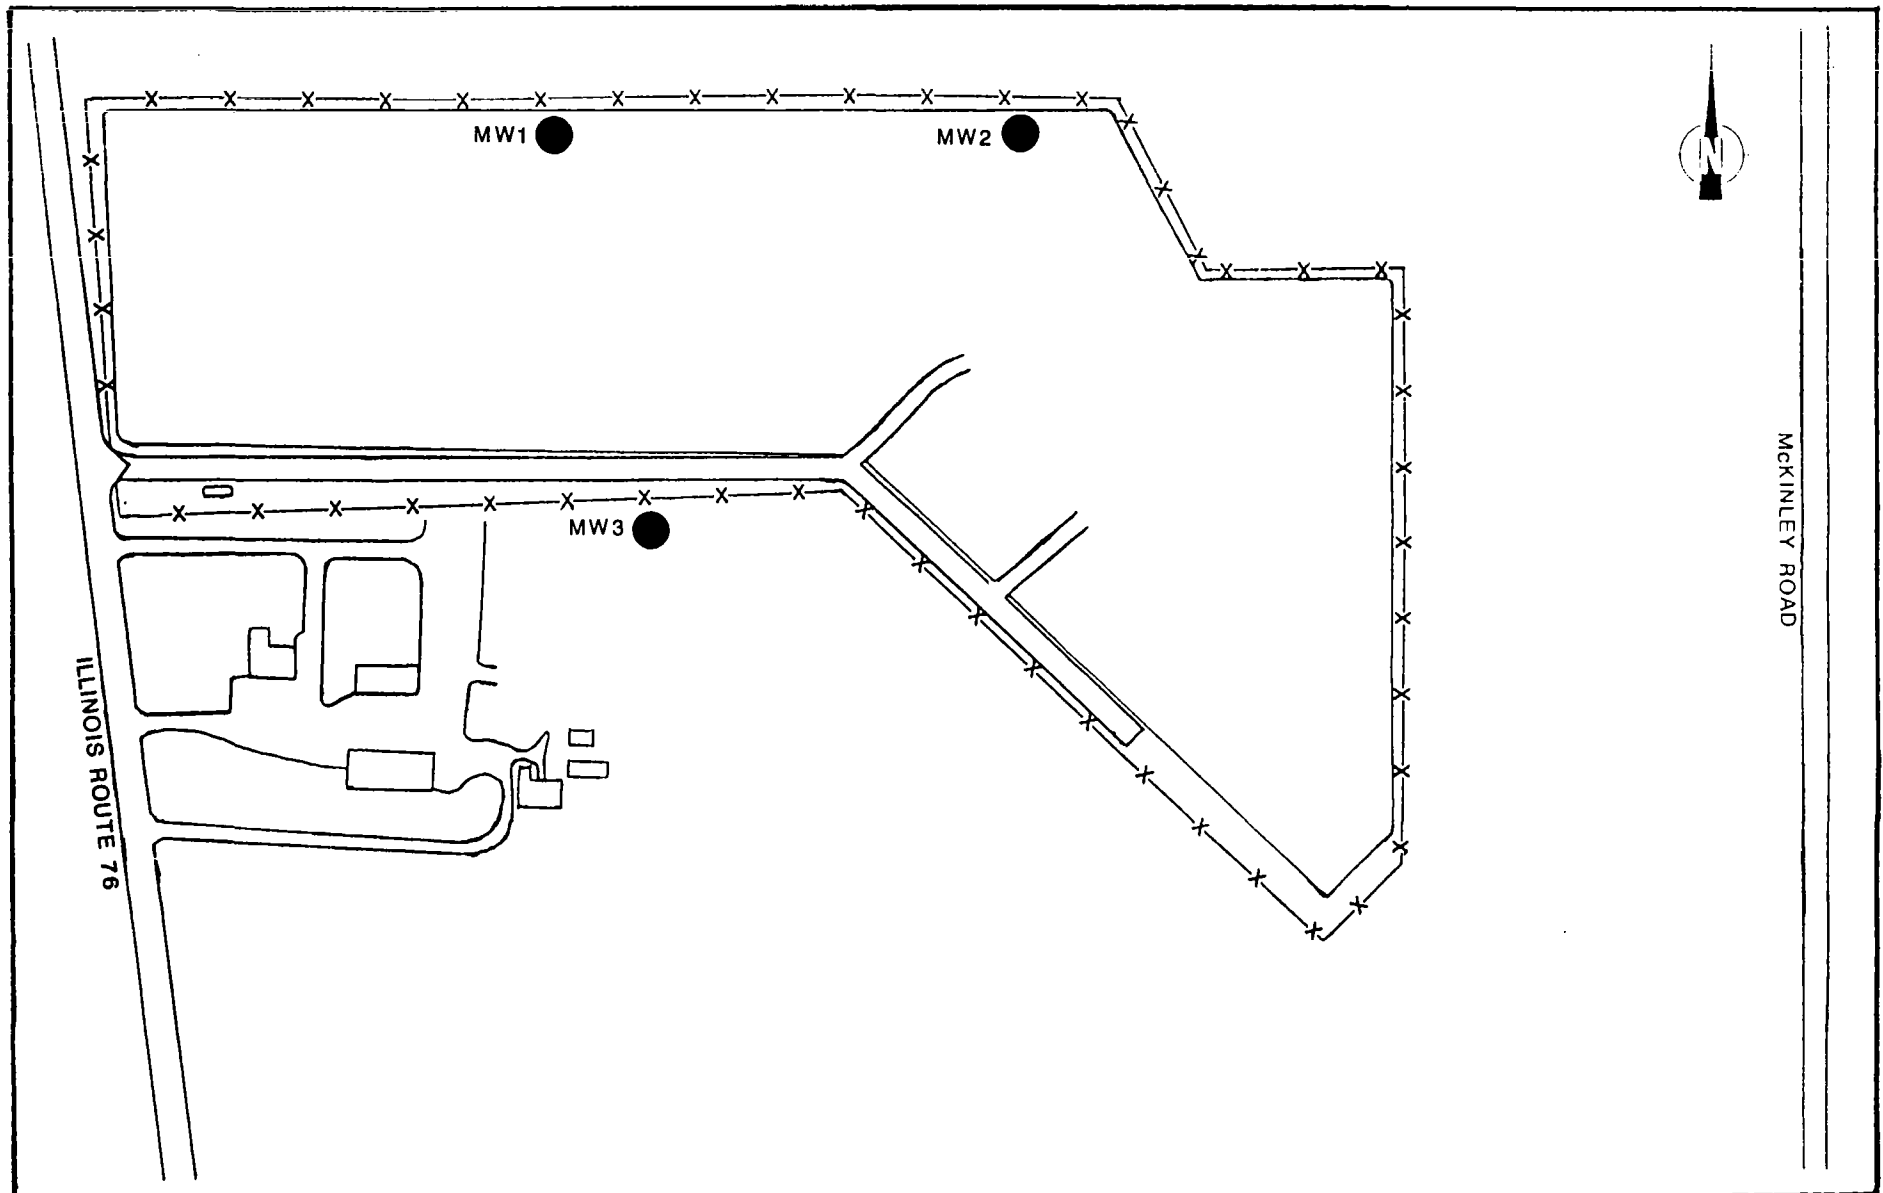
Monitoring Well Sampling Procedures. Three monitoring well samples (indicated as MW1, MW2, and MW3) were collected to determine whether TCL compounds and/or TAL analytes had migrated from the site into groundwater. Sample MW1 was collected at a well labeled G103 by the City of Belvidere. The well was Non-responsive of the landfill (see Figure 3-3 for monitoring well sampling locations). Sample MW2 was collected at a well (labeled G102 by the City of Belvidere) Non-responsive. Sample MW3 was collected at a well (labeled G110 by the City of Belvidere) Non-responsive.

While venting MW2, FIT detected elevated readings of methane with the OVA 128. FIT also observed that MW3 did not have a cap fitting onto the polyvinyl chloride (PVC) casing of the well and that the cover over the well was not locked. FIT noticed an odor at MW3 upon venting the well, although no readings were detected with the OVA 128.

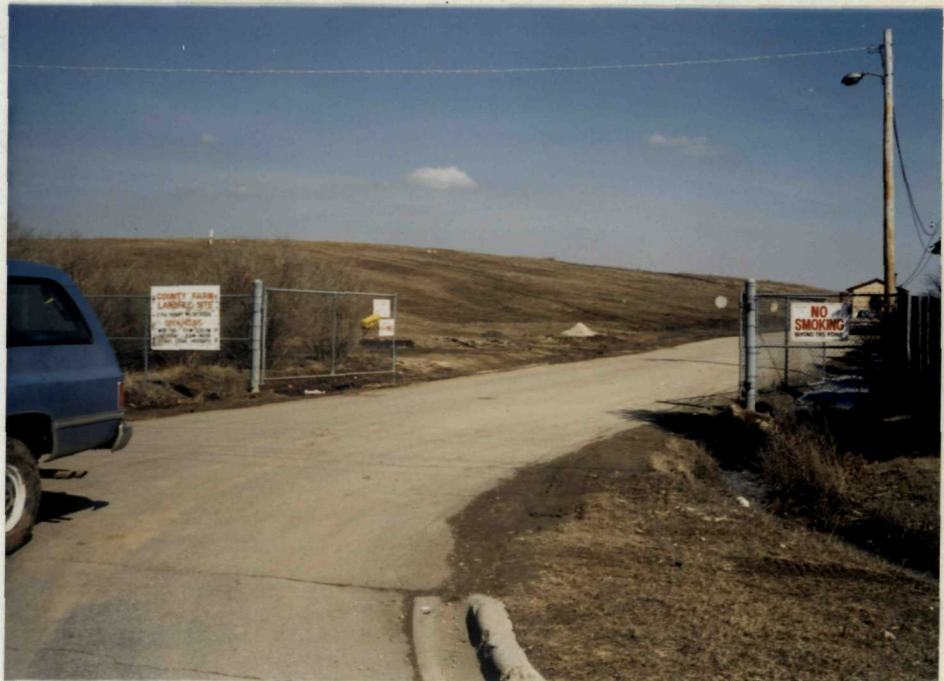
DESCRIPTION: Photograph of entrance gate with landfill and scale house in background.

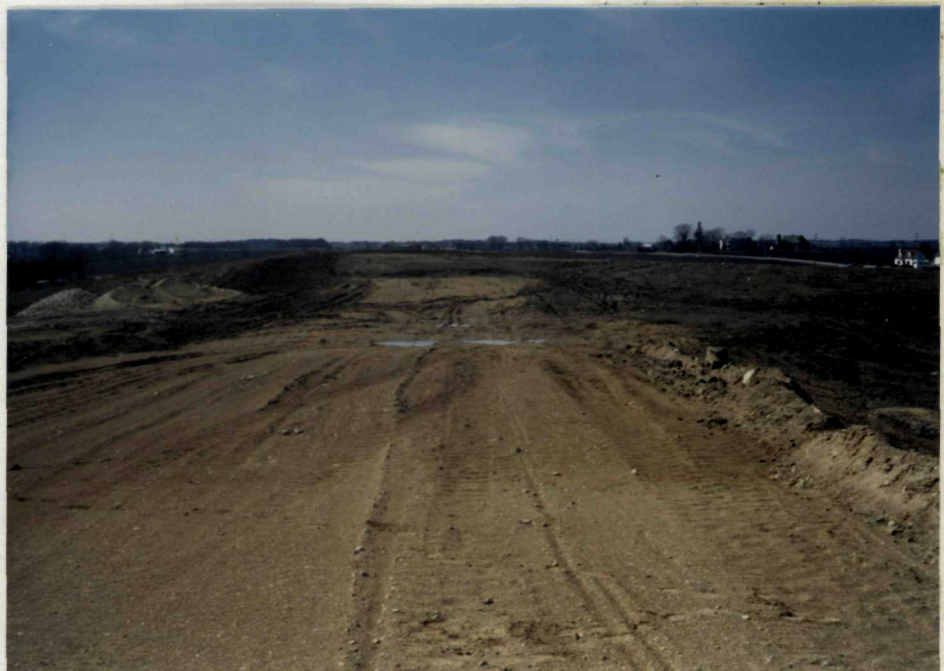
DESCRIPTION: Photograph from top of landfill of area to be capped in the spring of 1989.

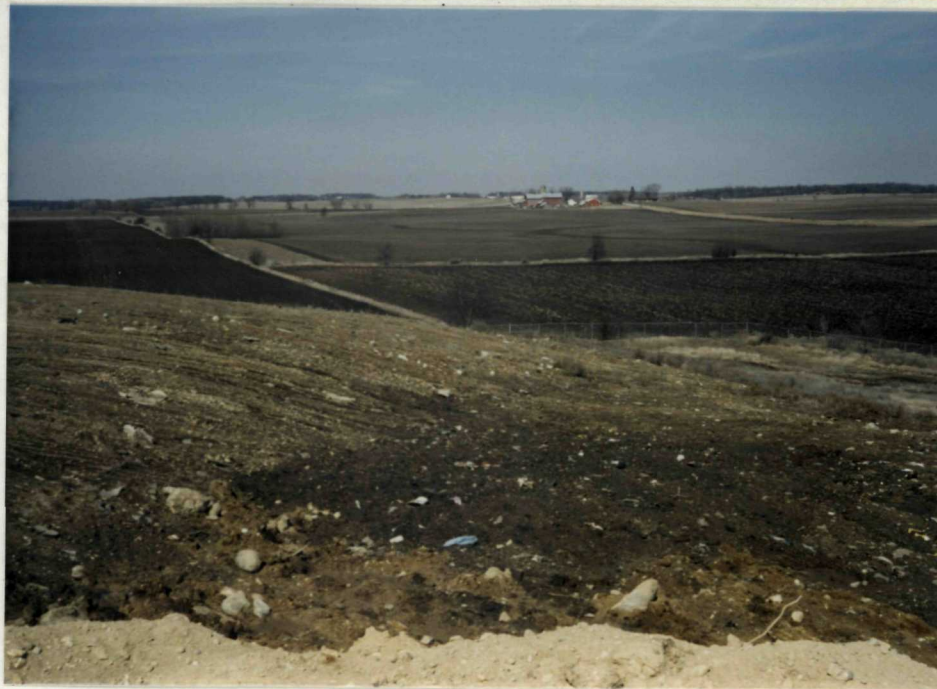
DESCRIPTION: Photograph from top of landfill at west
end where active land filling starts.DATE: 3-22-89TIME: 1310DIRECTION OF
PHOTOGRAPH:NEWEATHER
CONDITIONS:20°Fclear, sunny

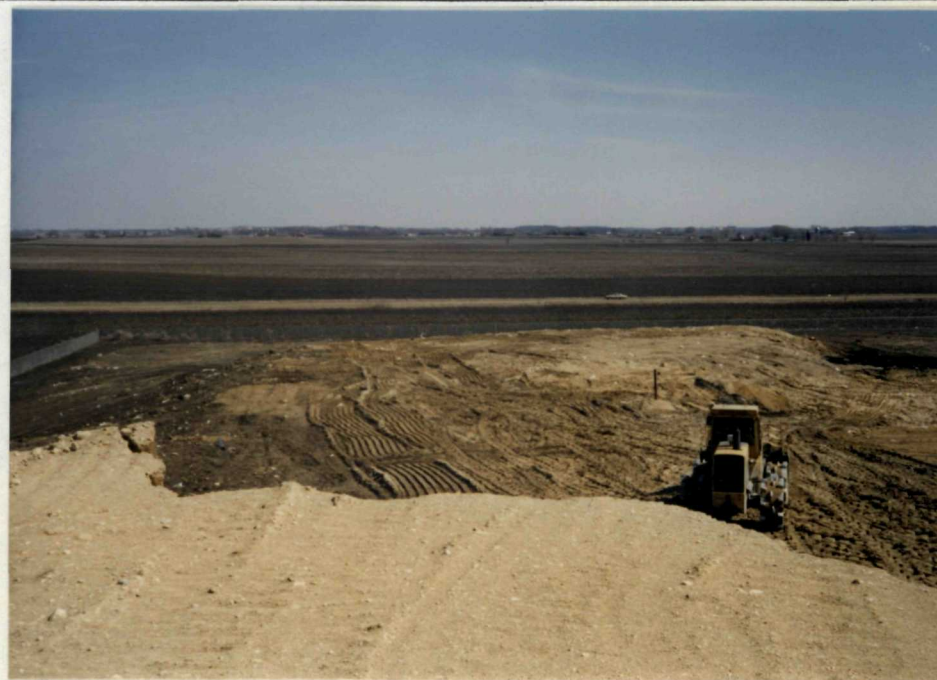
DESCRIPTION: Photograph from top of landfill standing
on daily cover material with active land filling area
in background. End loader covering refuse with daily cover.

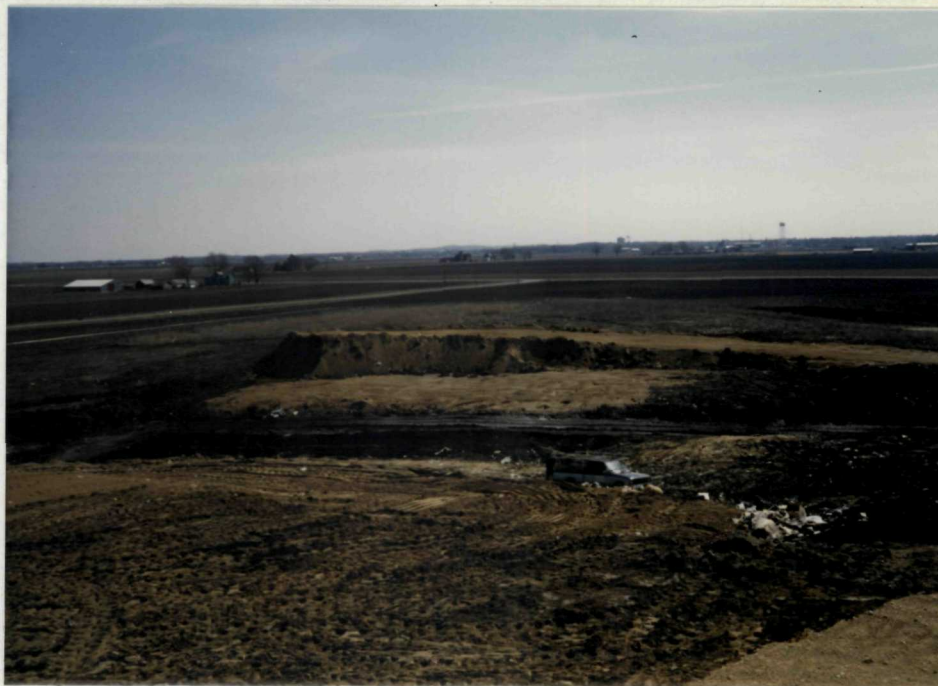
DESCRIPTION: Photograph from top of landfill of
active landfilling area with stockpiled daily cover
material in background. Also future landfilling area in background.DATE: 3-22-89TIME: 1305DIRECTION OF
PHOTOGRAPH:SWEATHER
CONDITIONS:20°Fclear, sunny

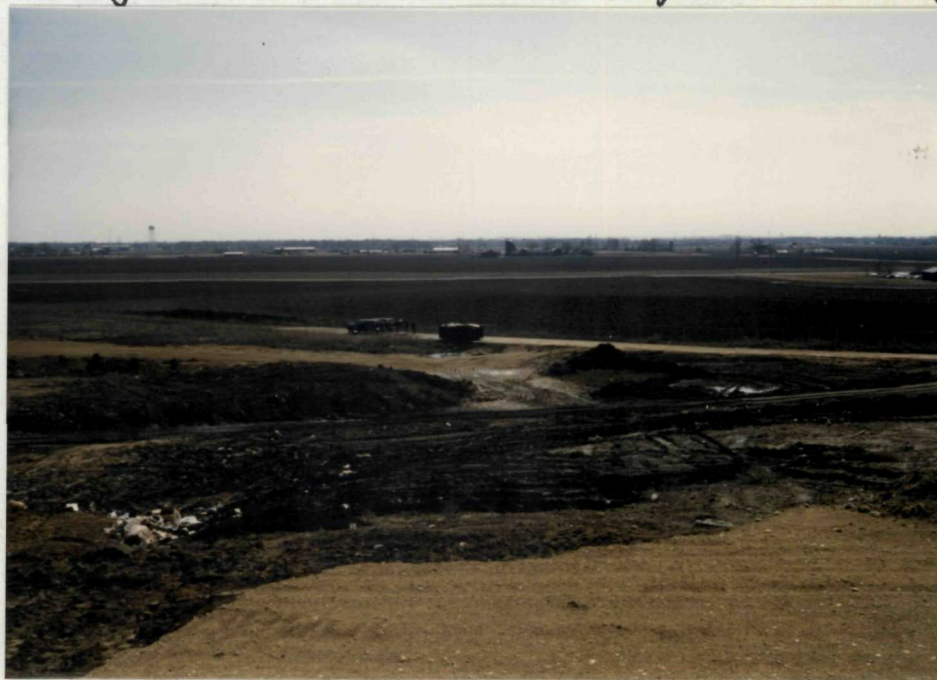
DESCRIPTION: Photograph from top of landfill with active
landfilling area in foreground.

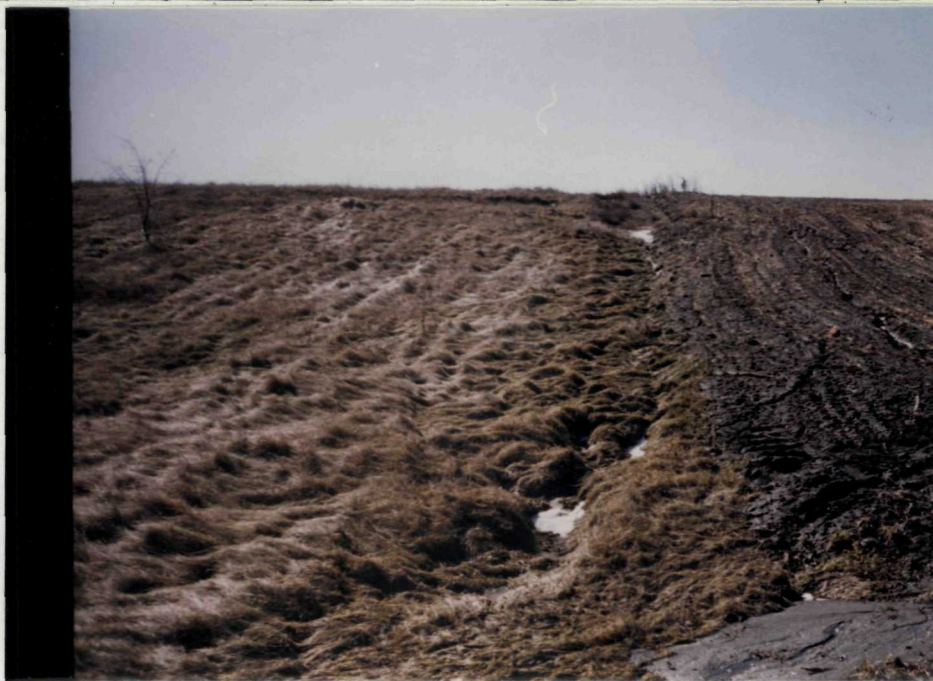
DESCRIPTION: Photograph of intersection between area
with final cap (right) and area to be capped
in the spring of 1989 (left).

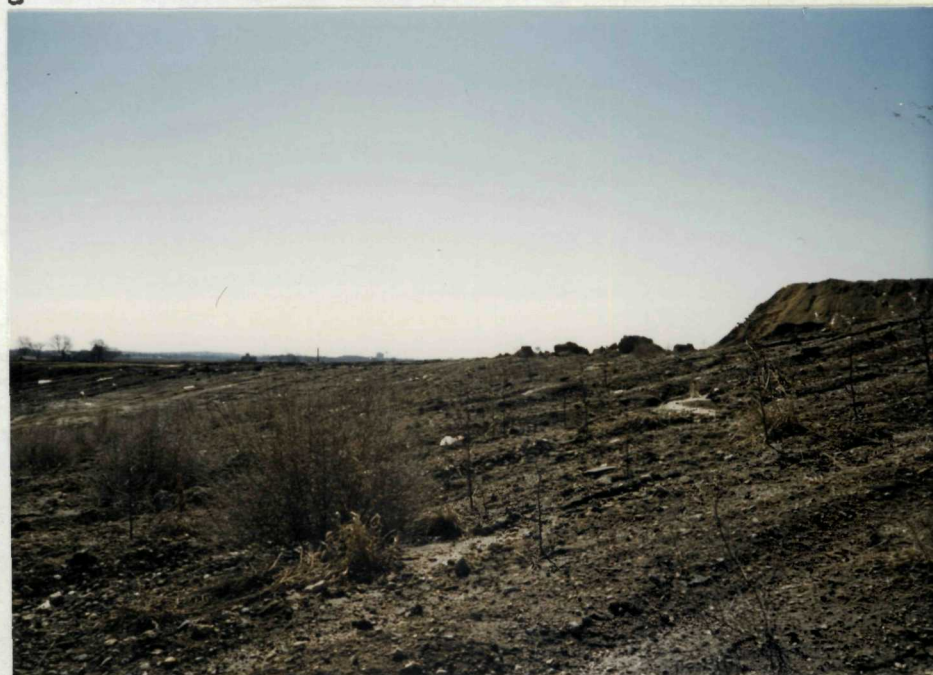
DESCRIPTION: Photograph of area to be capped with
final cover and stockpiled daily cover material
in right of photograph.

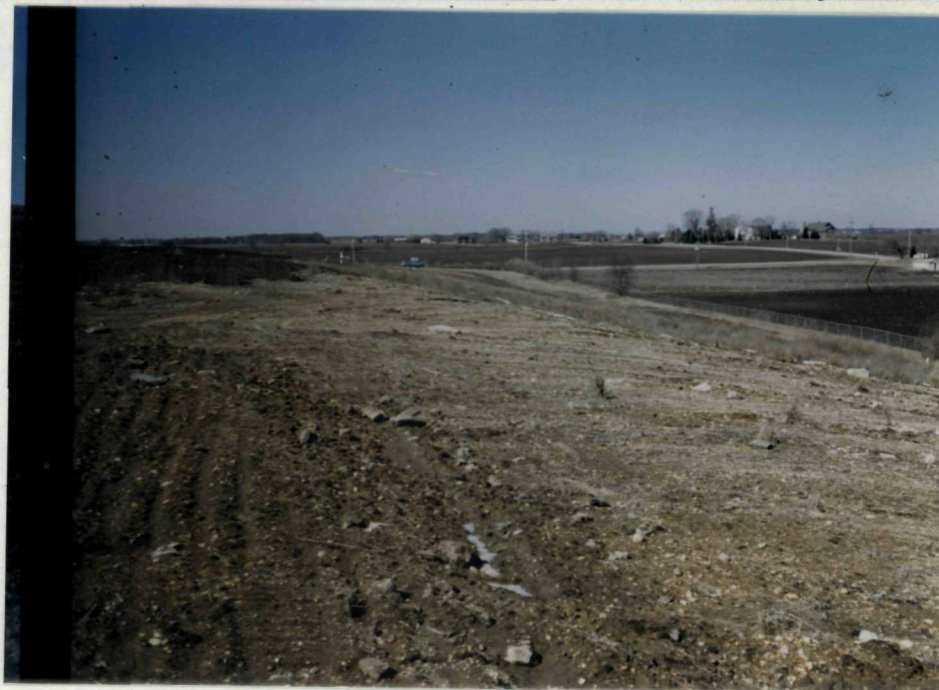
DESCRIPTION: Photograph of area to be capped in
spring of 1989 and methane collection pipes in right
of photograph which were abandoned.DATE: 3-22-89TIME: 1310DIRECTION OF
PHOTOGRAPH:NEWEATHER
CONDITIONS:20°Fclear, sunny

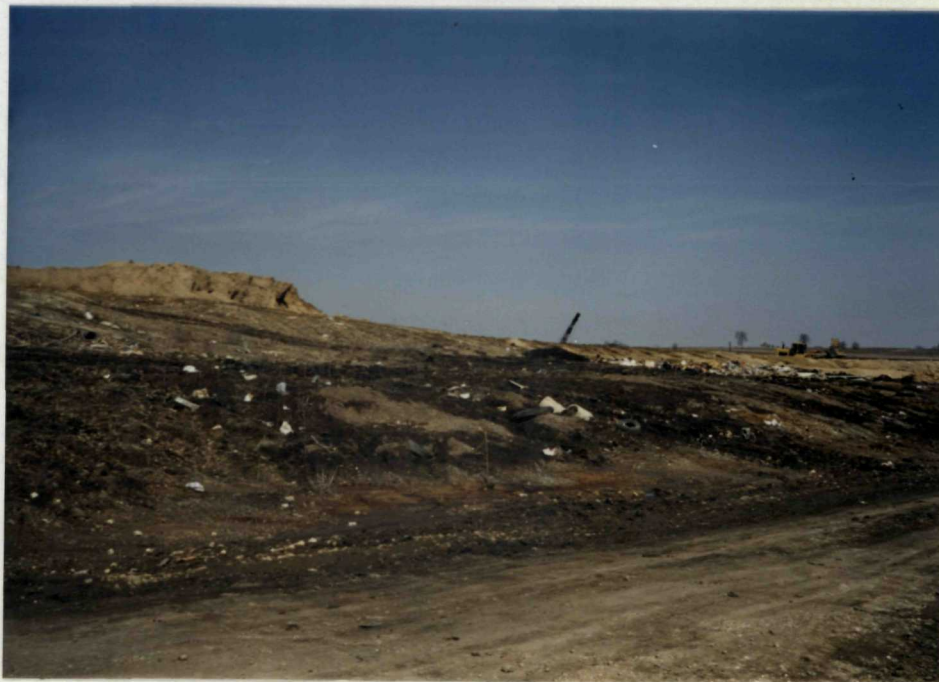
Along the north slope of the capped area of the landfill, several erosion gullies were observed, although no refuse was exposed. On the eastern half of the north slope FIT observed stained soil at the bottom of some erosion gullies. Approximately 765 feet east of the western boundary of the landfill, near the northern boundary of the landfill, FIT detected methane readings above background in the breathing zone, using an OVA 128 equipped with a charcoal filter. These readings were recorded in the vicinity of the abandoned methane collection pipes.

DESCRIPTION: Photograph taken from access road
with stained soil along side roadway in center
of photograph.

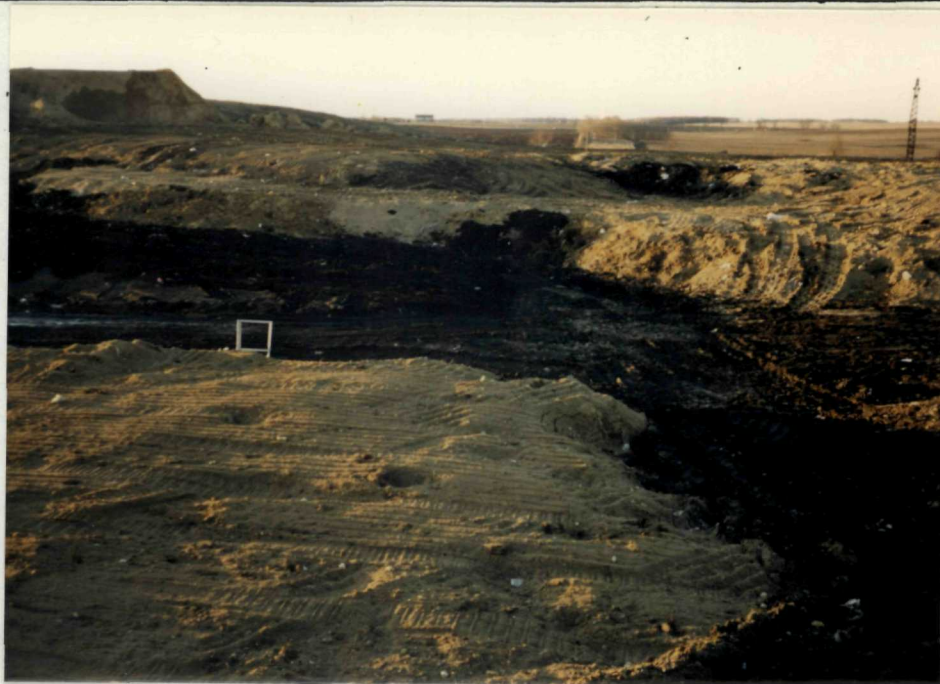
DESCRIPTION: Photograph taken from active fill area
showing depth of of daily cover.

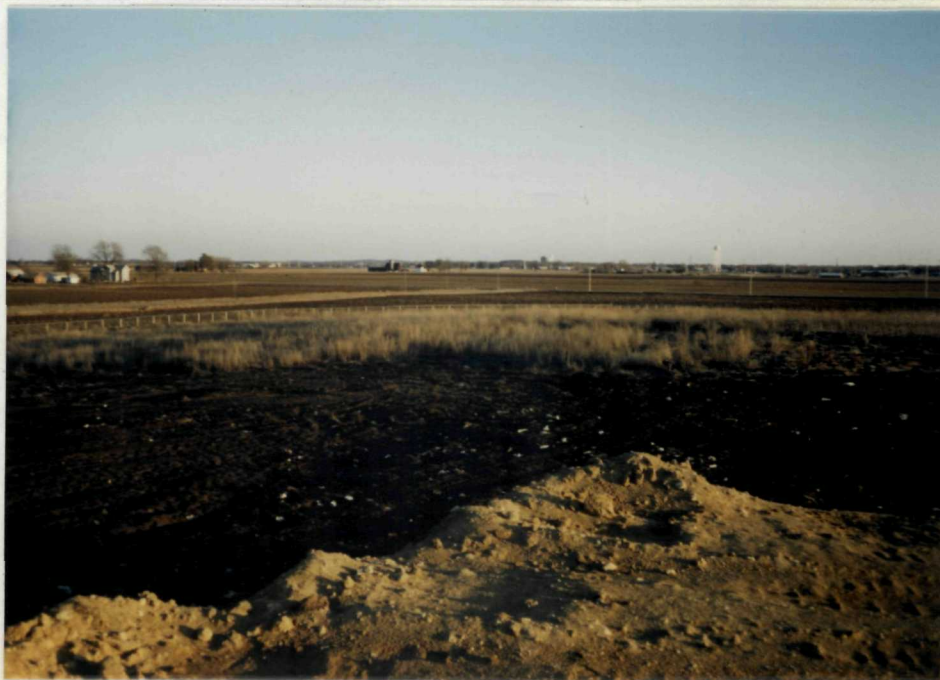
DESCRIPTION: Photograph taken from active fill area
of future landfill area.

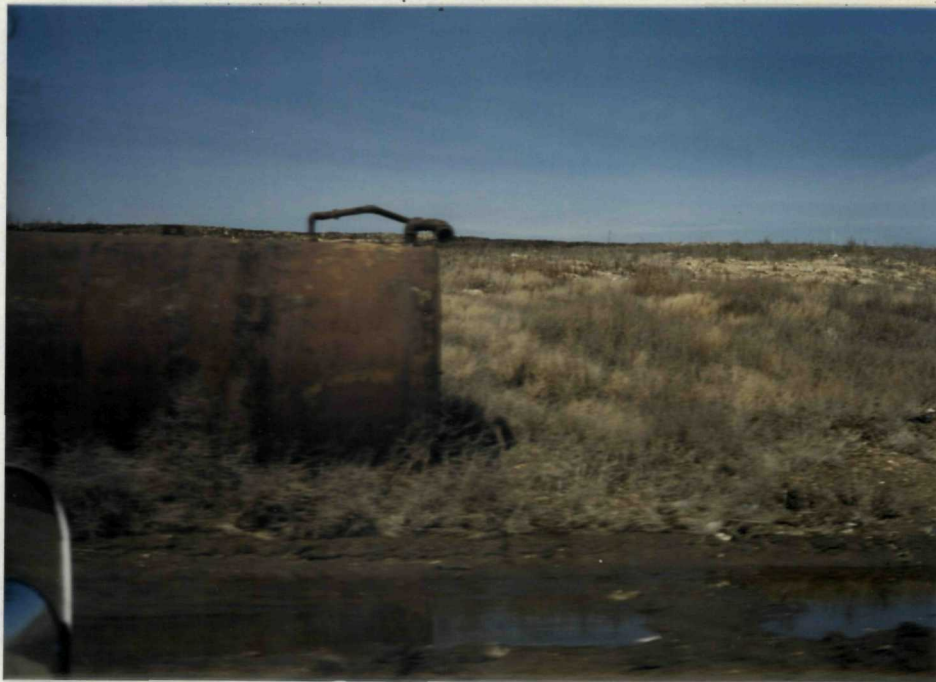
DESCRIPTION: Photograph of underground tank on site
which was brought to landfill empty.

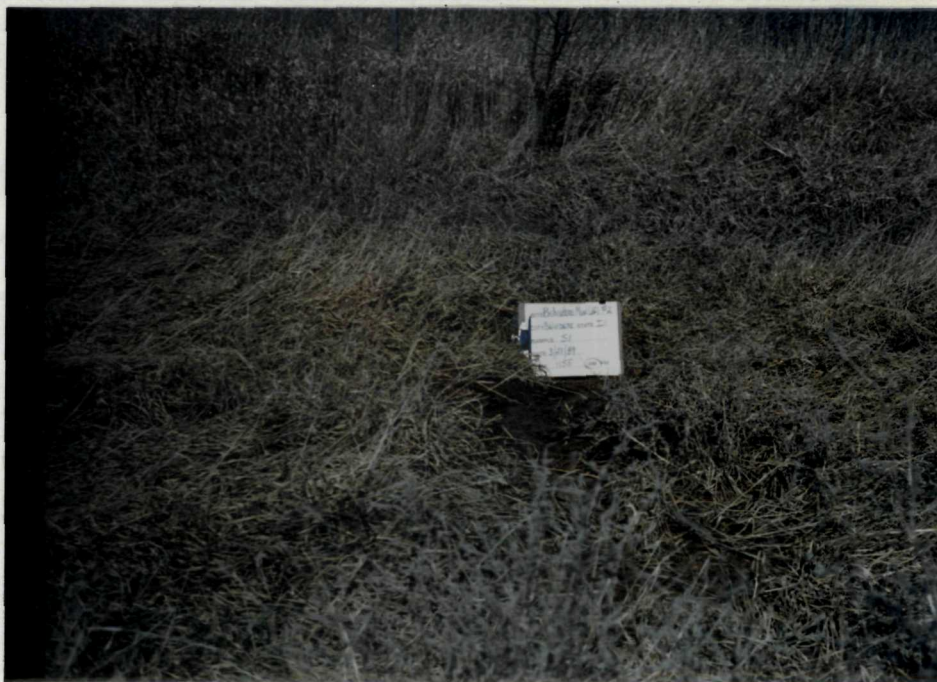
DESCRIPTION: Close up photograph of 51. Sample was collected at the surface along the fence on the north side.DATE: 3-21-89TIME: 1155DIRECTION OF
PHOTOGRAPH:NWEATHER
CONDITIONS:30°Fclear, Sunny

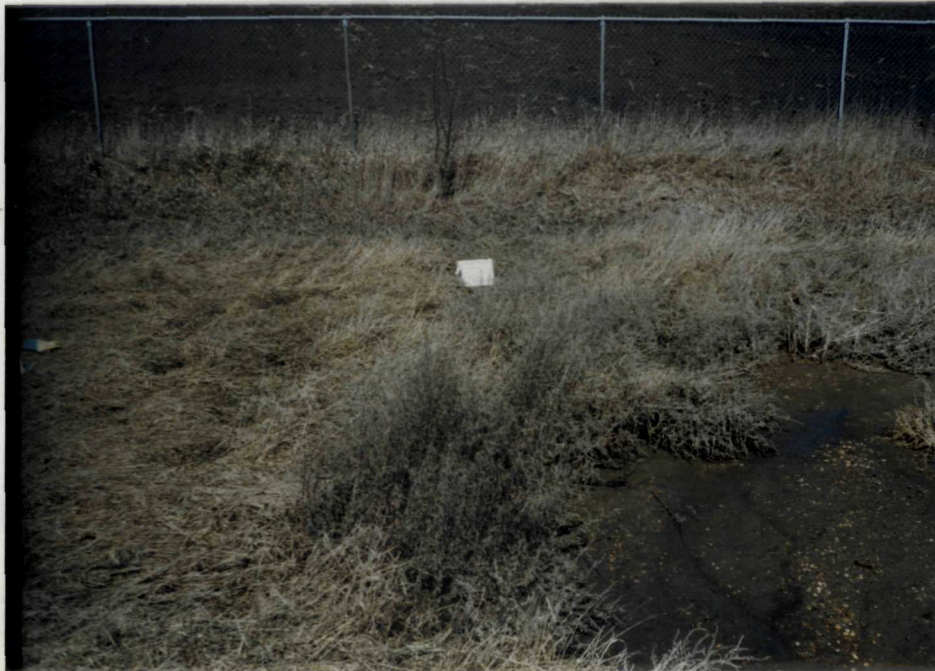
DESCRIPTION: Perspective photograph of 51. Sample taken below erosion gully.

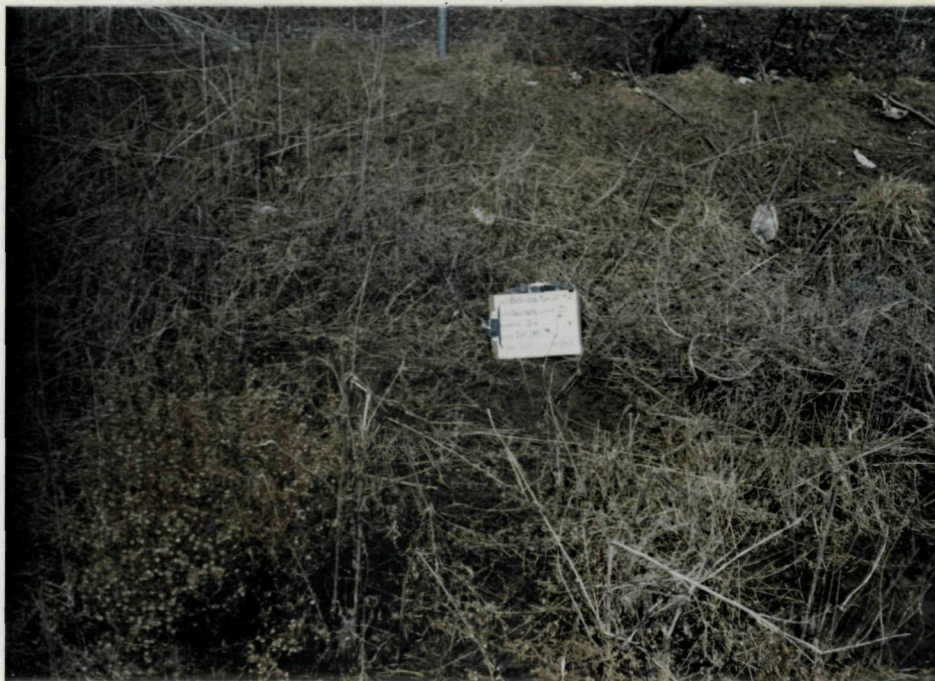
DESCRIPTION: Close up photograph of 52. Sample collected
at surface along the fence on the north side of landfill.DATE: 3-21-89TIME: 1215DIRECTION OF
PHOTOGRAPH:NWEATHER
CONDITIONS:30°Fclear, sunny

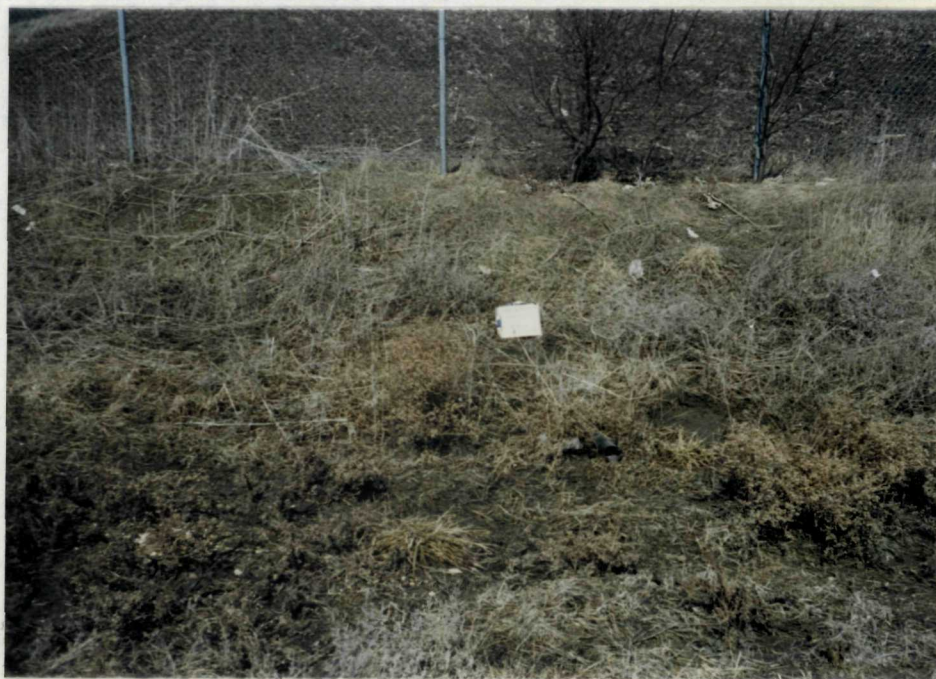
Wm PerpichSAMPLE ID
(if applicable):52

DESCRIPTION: Perspective photograph of 52.

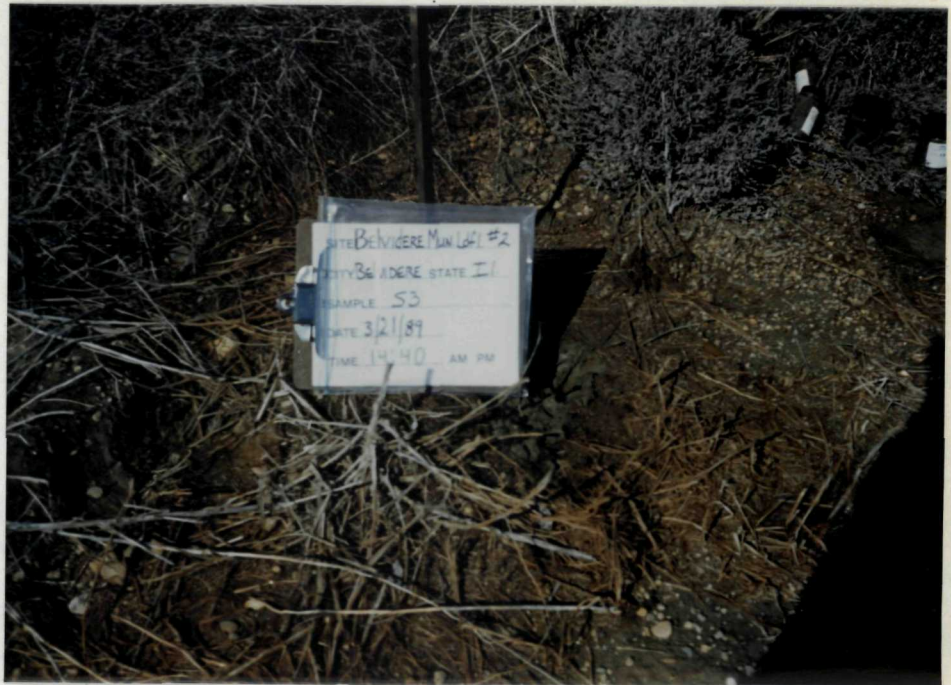
DESCRIPTION: Close up photograph of S3. Sample collected
along south slope of landfill in area of stained
soil.DATE: 3-21-89TIME: 1440DIRECTION OF
PHOTOGRAPH:NNEWEATHER
CONDITIONS:30°Fclear, Sunny

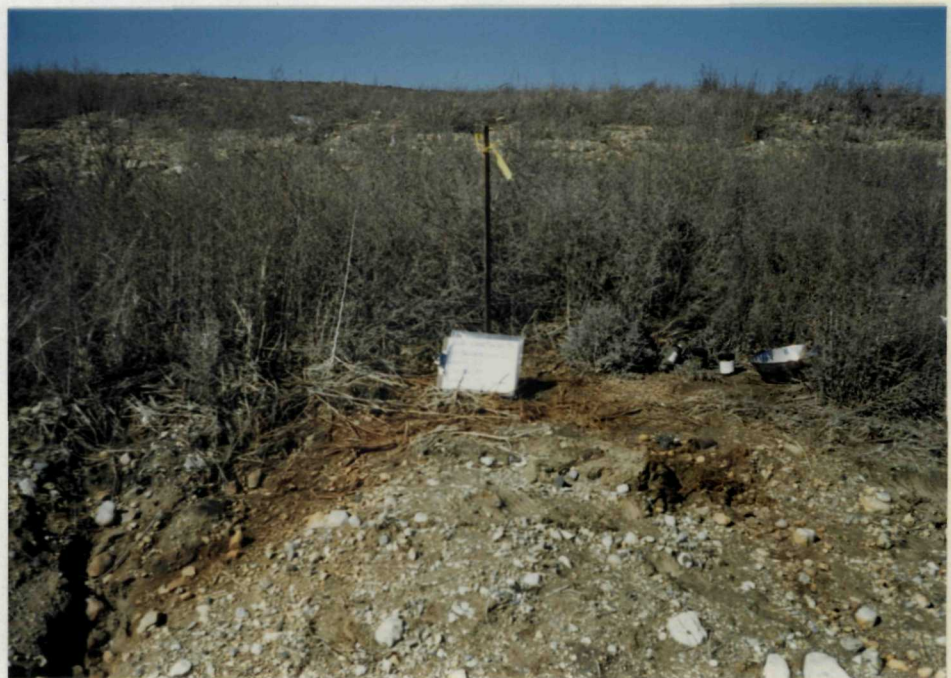
Wm PerpichSAMPLE ID
(if applicable):53

DESCRIPTION: Perspective photograph of S3.

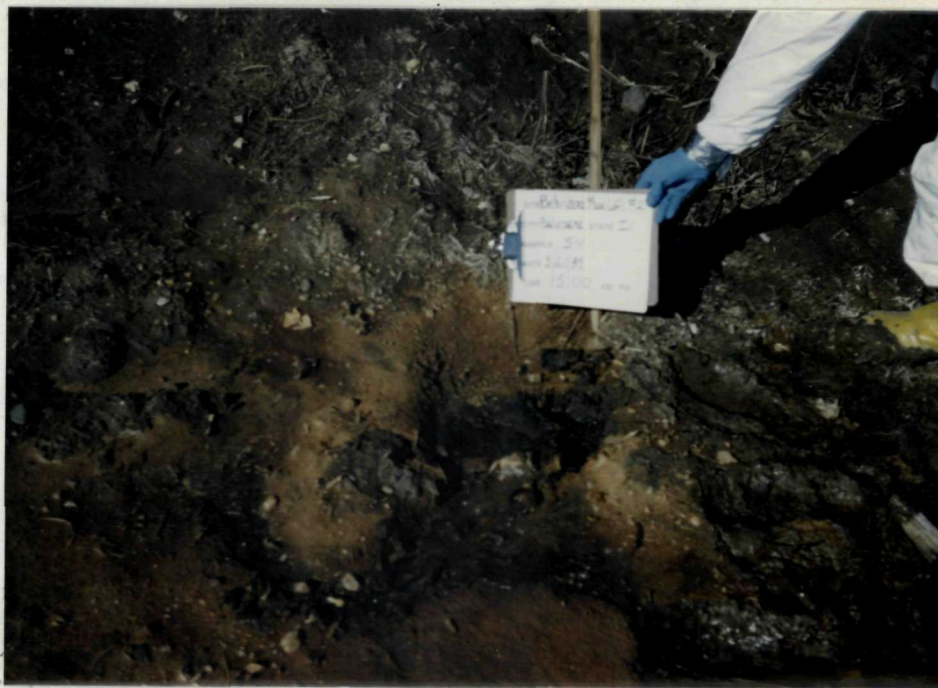
DESCRIPTION: Close up photograph of 54. Sample
collected at surface in area of stained soil.DATE: 3-21-89TIME: 1500DIRECTION OF
PHOTOGRAPH:NNEWEATHER
CONDITIONS:30°Fclear, Sunny

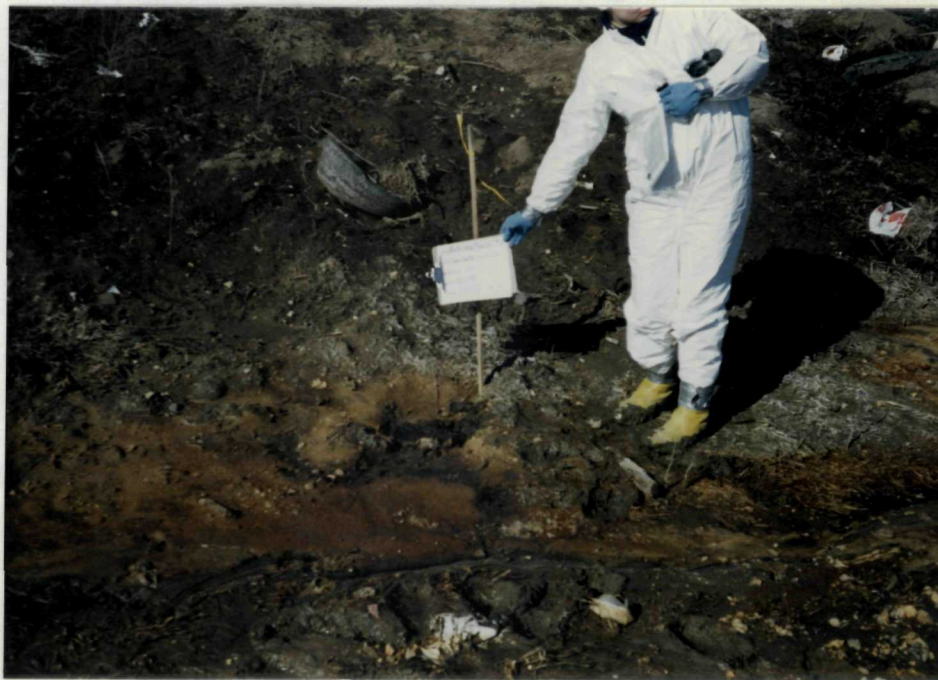
Wm PerpichSAMPLE ID
(if applicable):54

DESCRIPTION: Perspective photograph of 54.

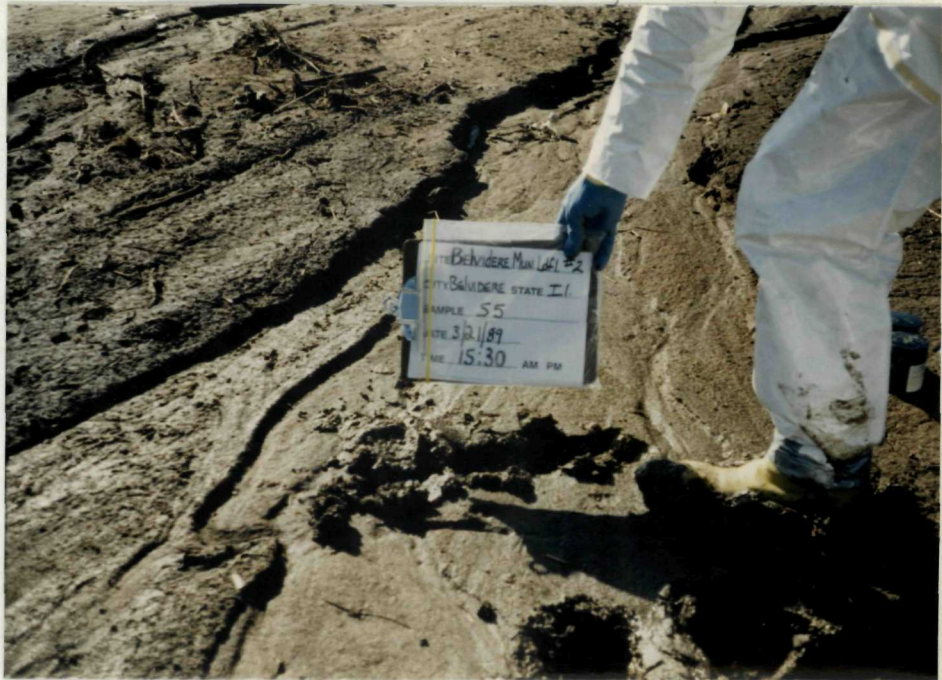
DESCRIPTION: close up photograph of 55. Sample collected at surface of landfill in area with erosion.DATE: 3-21-89TIME: 1530DIRECTION OF
PHOTOGRAPH:NWWEATHER
CONDITIONS:30°Fclear, Sunny

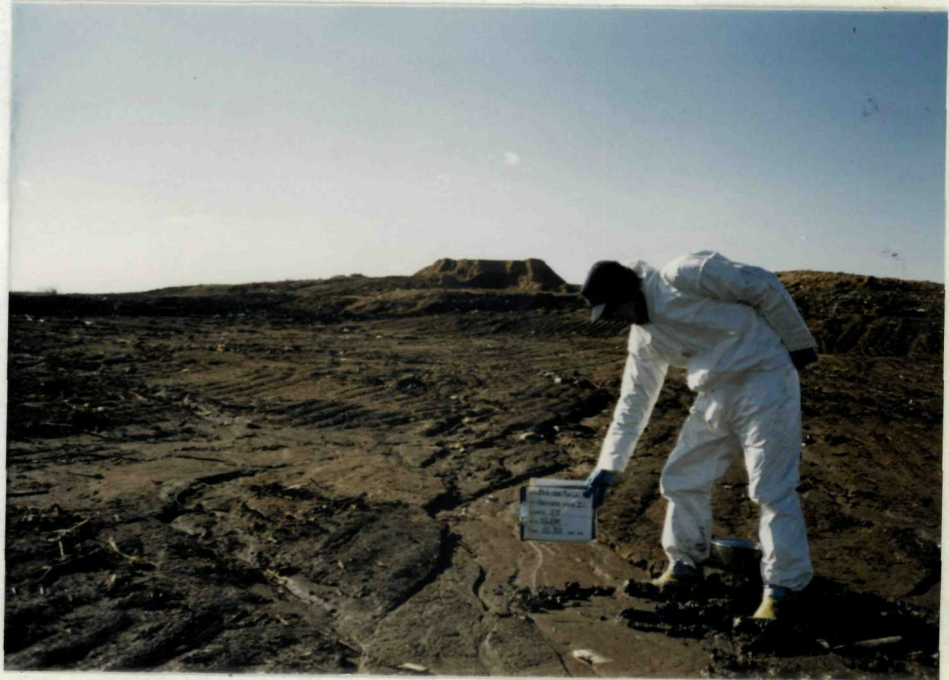
Wm PerpichSAMPLE ID
(if applicable):55

DESCRIPTION: Perspective photograph of 55.

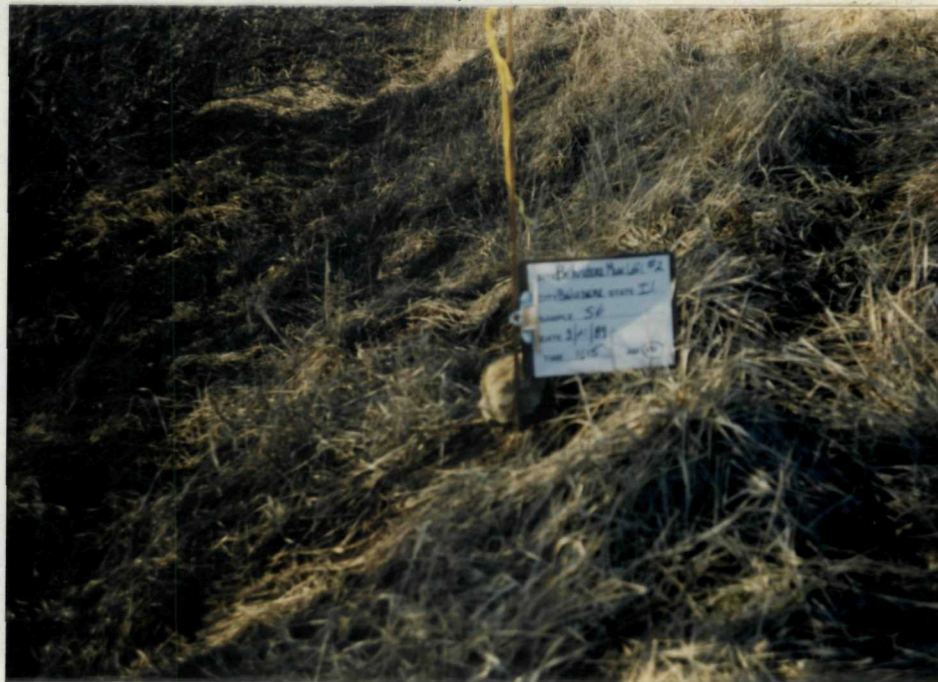
DESCRIPTION: close up photograph of 56. Sample collected
at surface on slope at west end of landfill.DATE: 3-21-89TIME: 1615DIRECTION OF
PHOTOGRAPH:NWEATHER
CONDITIONS:30°Fclear, Sunny

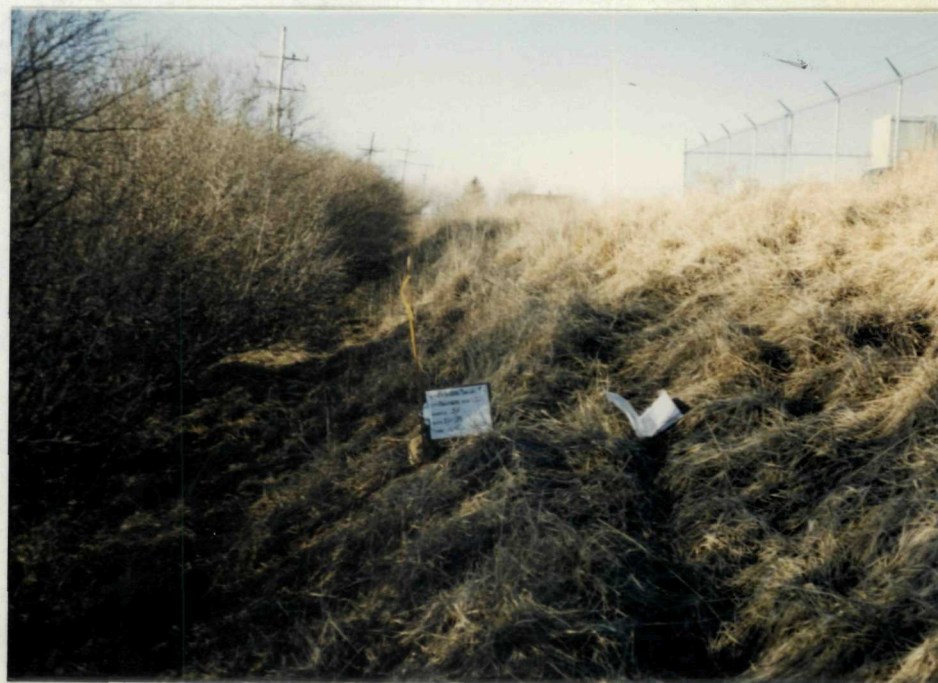
Wm PerpichSAMPLE ID
(if applicable):56

DESCRIPTION: Perspective photograph of 56.

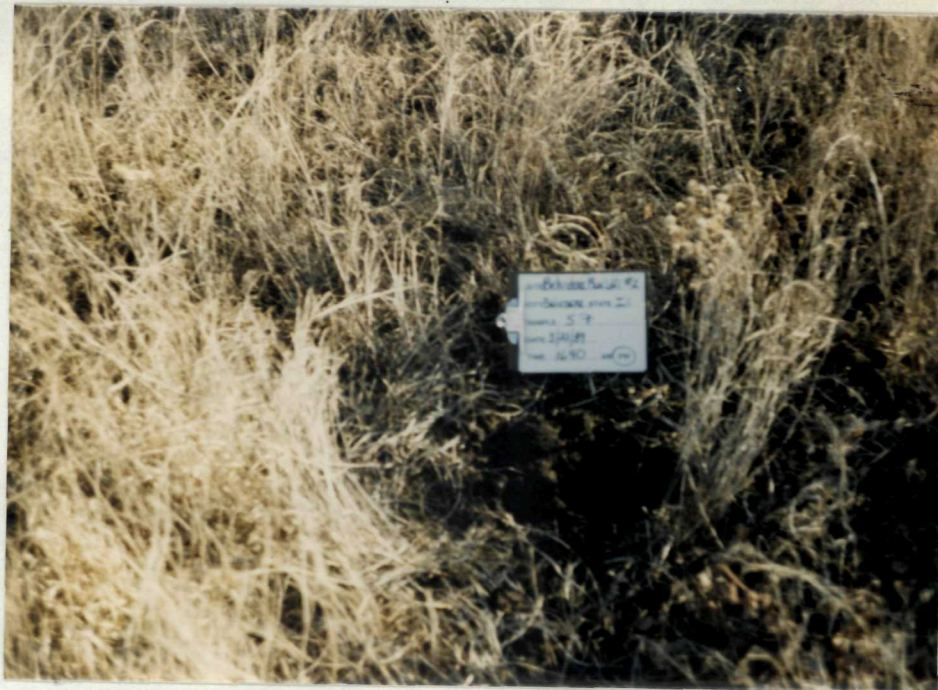
DESCRIPTION: close up photograph of 57 which is
the background sample collected in the southeast
corner of Route 76 and Woodstock Road.DATE: 3-21-89TIME: 1640DIRECTION OF
PHOTOGRAPH:EWEATHER
CONDITIONS:30°Fclear, sunny

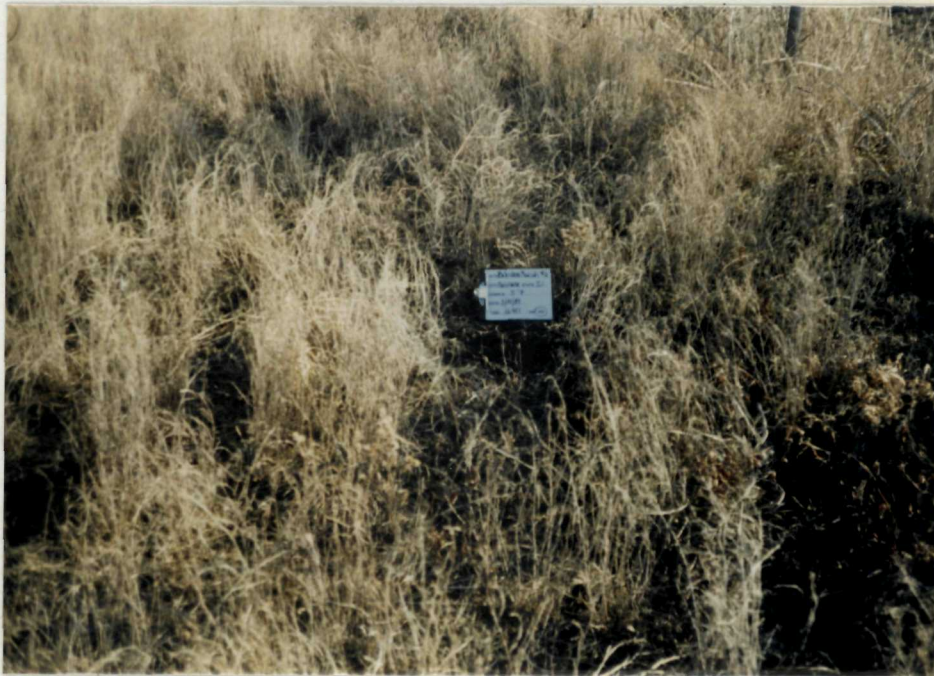
Wm PerpichSAMPLE ID
(if applicable):57

DESCRIPTION: Perspective photograph of 57.
